**Flood Control Project Maintenance
Levee Inspections**

Maintenance Issue Types Only, Levee Inspection Report By Mile - Fall 2019

Tehama County Flood Control and Water Conservation District

Waterway	Bank	Unit Miles	Inspection Start/End	Inspector
Unit No. 01 Deer Creek	Left	4.22	10/30/2019 10/30/2019	Makar Sokol

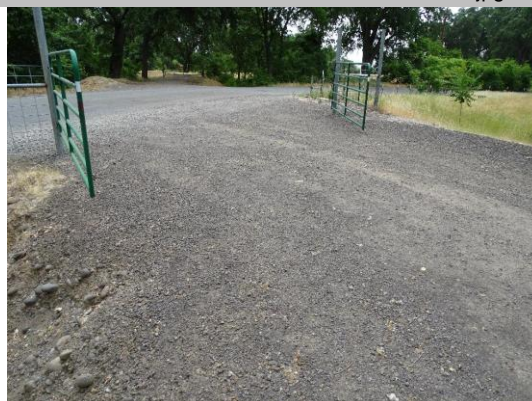
Photo 1 of 3 : UCIP_FA_2019_54008_79270.jpg

Overview of levee crown where pipe crosses

Comment Code						
Inspector Comment						
DS_ID:20769 FS_ID:54008 EP_NO: N/A Repair Type: Urgent Crossing Status: Found UCIP Comments: 05/14/2019 Same as last inspection. Flapgate on WS is missing, pipe partially blocked with sedimen. (O.Yakimov - DWR UCIP)10/15/2018 Flapgate on WS is missing, pipe partially blocked with sediment. (O.Yakimov - DWR)12/05/2016 same as last inspection. Crossing remains "Urgent" WS opened during flood season due to damaged flap gate. (O. Magana - DWR UCIP)10/02/2013 Flapgate missing or buried on WS toe. Pipe partially blocked by soil on WS toe. (W. Wylie - DWR UCIP) FIELD_STRUCT_DESC: 24-inch corrugated metal drainage pipe through the levee, 7 feet below the crown. Flap gate located on the waterside (WS) end. A 5-foot by 5-foot concrete control structure located on the landside (LS) toe. [Additional Reference(s): DWR Levee Log, 1992. USACE Sacramento O&M Manual Unit 509, March 1957, As-built drawing no. 50-4-2394 (Station 176+10)]. FS Date: 5/14/2019 4:05:54 PM

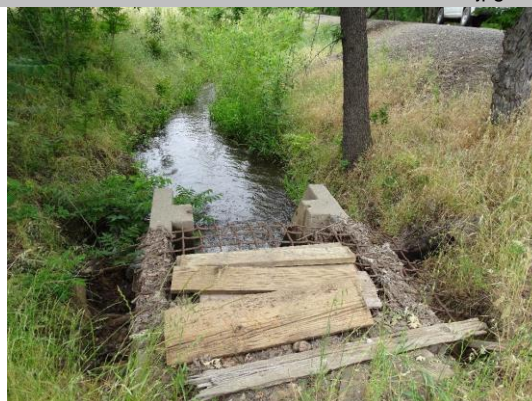
Photo 3 of 3 : UCIP_FA_2019_54008_79268.jpg

Concrete outfall structure at LS toe and irrigation canal

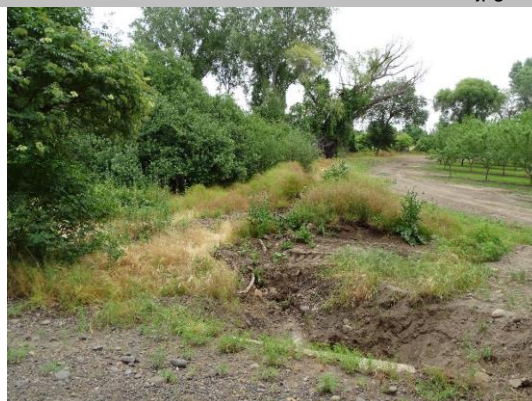
Photo 2 of 3 : UCIP_FA_2019_54012_79277.jpg

Comment Code						
Inspector Comment						
DS_ID:20767 FS_ID:54012 EP_NO: N/A Repair Type: Non-Urgent Crossing Status: Found UCIP Comments: 05/14/2019 Pipe outlet and headwall were excavated to evaluate pipe condition. Discovered a concrete pipe that connects nearby ditch with inlet of this crossing to drain water from the ditch. Cleared pipe outlet at WS toe. (O.Yakimov - DWR UCIP) Pipe blocked by soil. FIELD_STRUCT_DESC: 24-inch corrugated metal drainage pipe through the levee, 6 feet below the crown. Flap gate on the waterside (WS) end. [Additional Reference(s): DWR Levee Log, 1992. USACE Sacramento O&M Manual 509, March 1957, (Assumed Station 137+50) Drawing No. 50-4-2394]. FS Date: 5/14/2019 9:02:19 AM

View of landside with headwall at the toe

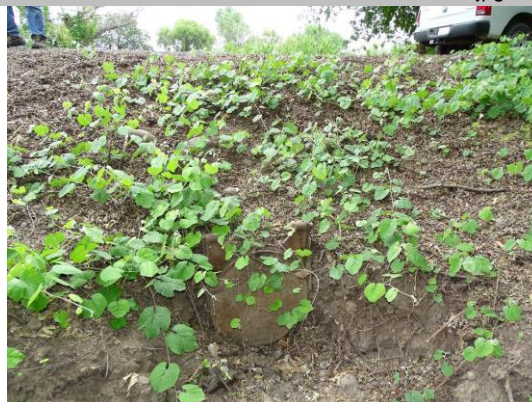
Photo 3 of 3 : UCIP_FA_2019_54012_79278.jpg

Pipe outlet with flap gate at WS toe

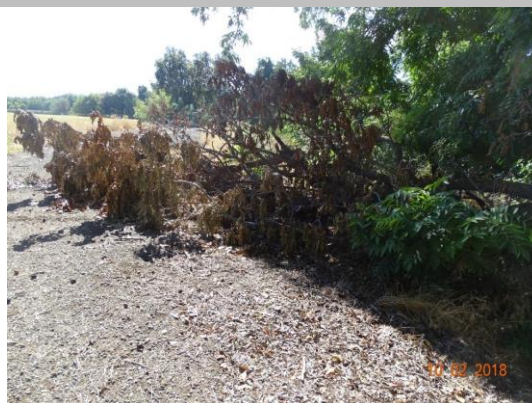
Photo 1 of 1 : FA_2019_NA0019_78_44_20190822_00017.jpg

LM Start	3.99	Rating **	M	Issue No.	44
LM End	3.99	Issue Type +	Ma	Location *	WS
Category	Earthen Levee		GPS Latitude/Longitude		
			Start	End	
Item	Encroachments		39.941990°	39.941990°	
			-122.057140°	-122.057140°	
DWR ID	DWR_NA0019_01_f_2018_44				
Comment Code					
TR : Tree or limb					
Inspector Comment					
The tree should be removed from the waterside slope.

View of the tree limb along the waterside slope.

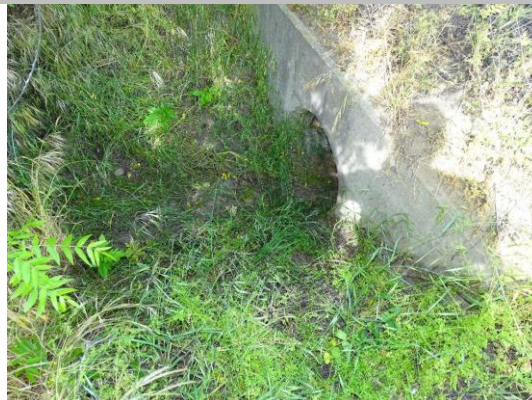
Photo 1 of 3 : UCIP_FA_2019_54023_79298.jpg

LM Start	4.03	Rating **	M	Issue No.	302
LM End	4.03	Issue Type +	Ma	Location *	
Category	Supplemental			GPS Latitude/Longitude	
				Start	End
Item	DRAFT DWR UCIP LMA Responsibility			39.941574 °	39.941574 °
				-122.057597 °	-122.057597 °
DWR ID	20760				
Comment Code					
Inspector Comment					
DS_ID:20760 FS_ID:54023 EP_NO: N/A Repair Type: Non-Urgent Crossing Status: Found UCIP Comments: 05/14/2019 No issues recorded during inspection. (O.Yakimov - DWR UCIP) FIELD_STRUCT_DESC: 24-inch corrugated metal drainage pipe through the levee, 5 feet below the crown. Flap gate on the waterside (WS) end. Headwalls on both sides of levee. [Additional Reference(s): DWR Levee Log, 1992. USACE Sacramento O&M Manual 509, March 1957, (Assumed Station 5+00) Drawing No. 50-4-2394]. FS Date: 5/14/2019 10:53:58 AM

Headwall and pipe inlet at LS toe

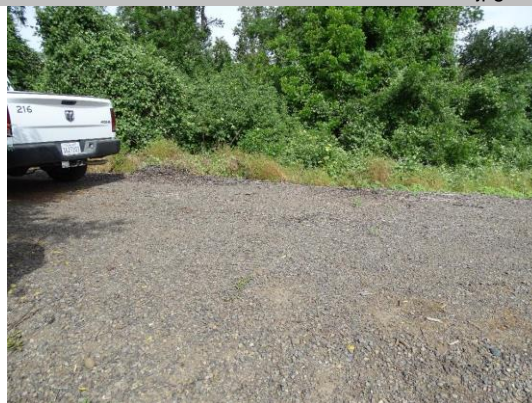
Photo 2 of 3 : UCIP_FA_2019_54023_79299.jpg

View of levee crown at the crossing

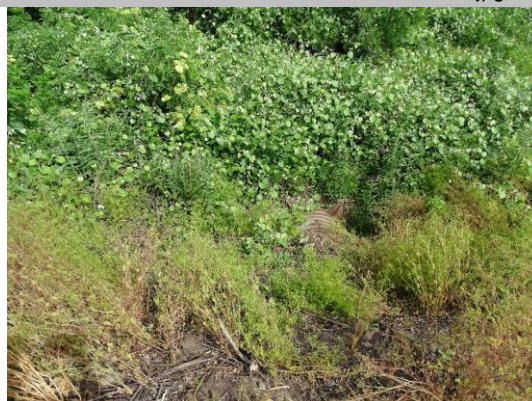
Photo 3 of 3 : UCIP_FA_2019_54023_79300.jpg

Comment Code						
Inspector Comment						
DS_ID:20760						
FS_ID:54023						
EP_NO: N/A						
Repair Type: Non-Urgent						
Crossing Status: Found						
UCIP Comments: 05/14/2019 No issues recorded during inspection.						
(O.Yakimov - DWR UCIP)						
FIELD_STRUCT_DESC: 24-inch corrugated metal drainage pipe						
through the levee, 5 feet below the crown. Flap gate on the waterside						
(WS) end. Headwalls on both sides of levee. [Additional Reference(s):						
DWR Levee Log, 1992. USACE Sacramento O&M Manual 509, March						
1957, (Assumed Station 5+00) Drawing No. 50-4-2394].						
FS Date: 5/14/2019 10:53:58 AM

Pipe and flap gate at WS slope

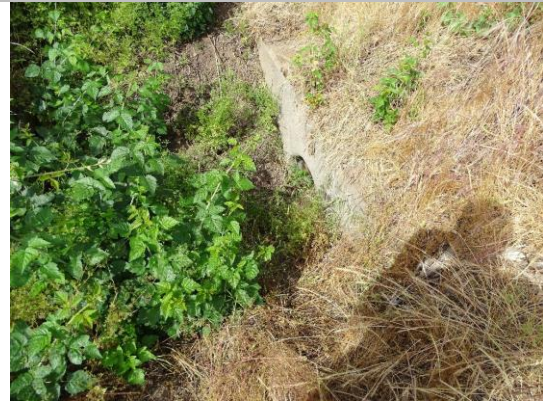
Photo 1 of 3 : UCIP_FA_2019_54024_79304.jpg

Comment Code						
Inspector Comment						
DS_ID:20762 FS_ID:54024 EP_NO: N/A Repair Type: Urgent Crossing Status: Found UCIP Comments: 05/14/2019 Missing flap gate, pipe outlet is silted. (O.Yakimov - DWR UCIP)10/15/2018 Missing flap gate at WS end of the pipe. Pipe is partially blocked with silt. Updated coordinates and CLM. (O.Yakimov - DWR)12/05/2016 unable to complete inspection -- unable to locate. (O. Magana - DWR UCIP)10/03/2013 Gate missing from WS toe. (W. Wylie - DWR UCIP) FIELD_STRUCT_DESC: 24-inch corrugated metal drainage pipe through the levee, 5.5 feet below the crown. Flap gate located on the waterside (WS) end. Concrete headwall located on the landside (LS) toe. [Additional Reference(s): DWR Levee Log, 1992. USACE Sacramento O&M Manual Unit 509, March 1957, As-built drawing no. 50-4-2394 (Station 0+65)]. FS Date: 5/14/2019 11:01:16 AM

Headwall and inlet at LS toe

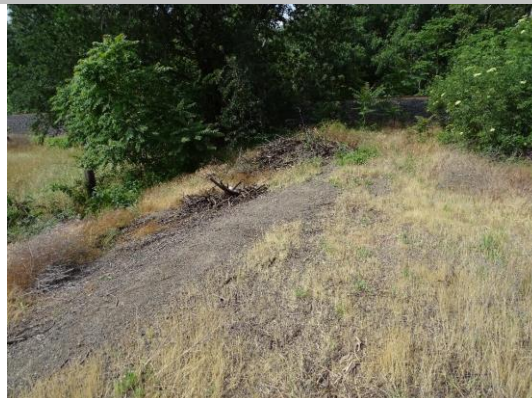
Photo 3 of 3 : UCIP_FA_2019_54024_79303.jpg

Comment Code						
Inspector Comment						
DS_ID:20762 FS_ID:54024 EP_NO: N/A Repair Type: Urgent Crossing Status: Found UCIP Comments: 05/14/2019 Missing flap gate, pipe outlet is silted. (O.Yakimov - DWR UCIP)10/15/2018 Missing flap gate at WS end of the pipe. Pipe is partially blocked with silt. Updated coordinates and CLM. (O.Yakimov - DWR)12/05/2016 unable to complete inspection -- unable to locate. (O. Magana - DWR UCIP)10/03/2013 Gate missing from WS toe. (W. Wylie - DWR UCIP) FIELD_STRUCT_DESC: 24-inch corrugated metal drainage pipe through the levee, 5.5 feet below the crown. Flap gate located on the waterside (WS) end. Concrete headwall located on the landside (LS) toe. [Additional Reference(s): DWR Levee Log, 1992. USACE Sacramento O&M Manual Unit 509, March 1957, As-built drawing no. 50-4-2394 (Station 0+65)]. FS Date: 5/14/2019 11:01:16 AM

View of levee crown at the crossing

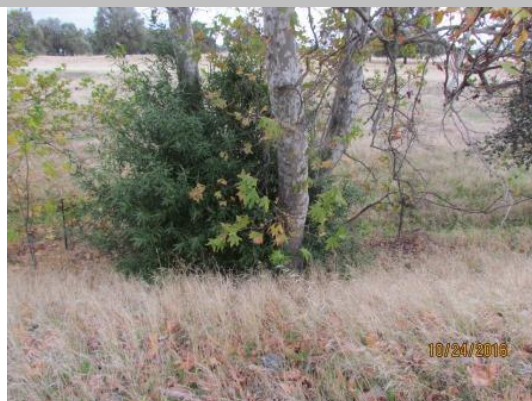
Photo 1 of 1 : FA_2019_NA0019_79_13_20190822_00007.jpg

LM Start	0.23	Rating **	M	Issue No.	13
LM End	0.23	Issue Type +	Ma	Location *	LS
Category	Earthen Levee			GPS Latitude/Longitude	
				Start	End
Item	Trim / Thin Trees			39.970598 °	39.970598 °
				-122.013053 °	-122.013053 °
DWR ID	DWR_NA0019_02_f_2016_13				
Comment Code					
T1 : Trim trees to at least five feet above ground level.					
Inspector Comment					
Remove trees smaller than 4-inches in diameter at chest height.

View of a tree with new thick growth blocking visibility.

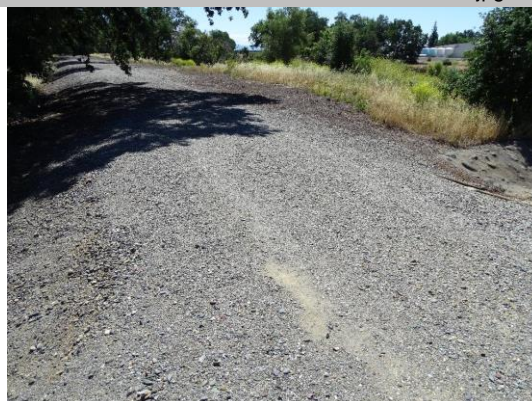
Photo 1 of 3 : UCIP_FA_2019_54114_79538.jpg

Comment Code					
Inspector Comment					
DS_ID:20775					
FS_ID:54114					
EP_NO: N/A					
Repair Type: Non-Urgent					
Crossing Status: Found					
UCIP Comments: 05/28/2019 Debris at the outlet needs to be cleared for proper flap gate operation. (O.Yakimov - DWR UCIP)					
FIELD_STRUCT_DESC: 24-inch corrugated metal drainage pipe through the levee, 4 feet below the crown. Flap gate and concrete U-shaped headwall on the waterside (WS) end. Concrete U-shaped headwall on the landside (LS) end. [Additional Reference(s): DWR Levee Log, 1992. USACE Sacramento O&M Manual 510, April 1963, (HLM 0.26) Drawing No. 50-4-3622].					
FS Date: 5/28/2019 7:19:25 AM

Top of Levee

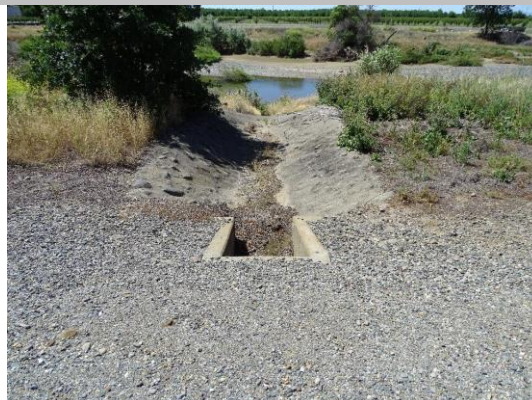
Photo 2 of 3 : UCIP_FA_2019_54114_79539.jpg

Water-Side

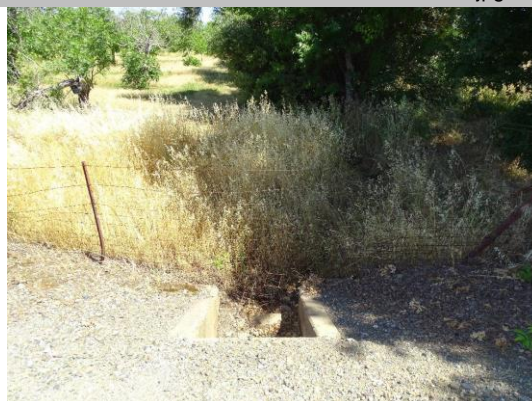
Photo 3 of 3 : UCIP_FA_2019_54114_79540.jpg

Comment Code						
Inspector Comment						
DS_ID:20775 FS_ID:54114 EP_NO: N/A Repair Type: Non-Urgent Crossing Status: Found UCIP Comments: 05/28/2019 Debris at the outlet needs to be cleared for proper flap gate operation. (O.Yakimov - DWR UCIP) FIELD_STRUCT_DESC: 24-inch corrugated metal drainage pipe through the levee, 4 feet below the crown. Flap gate and concrete U-shaped headwall on the waterside (WS) end. Concrete U-shaped headwall on the landside (LS) end. [Additional Reference(s): DWR Levee Log, 1992. USACE Sacramento O&M Manual 510, April 1963, (HLM 0.26) Drawing No. 50-4-3622]. FS Date: 5/28/2019 7:19:25 AM

Land-Side

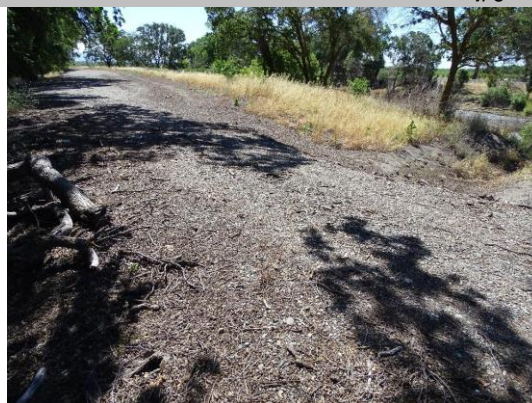
Photo 1 of 3 : UCIP_FA_2019_54115_79545.jpg

Comment Code						
Inspector Comment						
DS_ID:20776						
FS_ID:54115						
EP_NO: N/A						
Repair Type: Non-Urgent						
Crossing Status: Found						
UCIP Comments: 05/28/2019 Debris at the outlet needs to be cleared for proper flap gate operation. (O.Yakimov - DWR UCIP)						
FIELD_STRUCT_DESC: 24-inch corrugated metal drainage pipe through the levee, 4.5 feet below the crown. Flap gate and concrete U-shaped headwall on the waterside (WS) end. Concrete U-shaped headwall on the landside (LS) end. [Additional Reference(s): DWR Levee Log, 1992. USACE Sacramento O&M Manual 510, April 1963, (HLM 0.39) Drawing No. 50-4-3622].						
FS Date: 5/28/2019 9:41:55 AM

Top of Levee

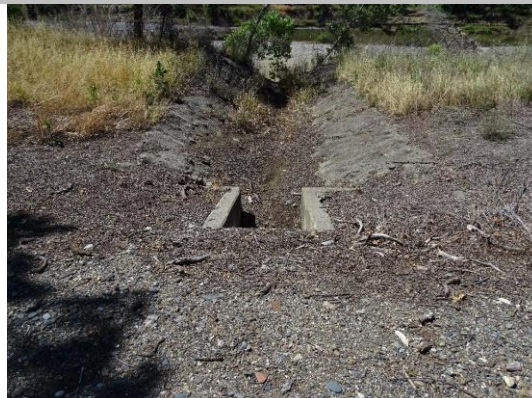
Photo 2 of 3 : UCIP_FA_2019_54115_79546.jpg

Comment Code						
Inspector Comment						
DS_ID:20776 FS_ID:54115 EP_NO: N/A Repair Type: Non-Urgent Crossing Status: Found UCIP Comments: 05/28/2019 Debris at the outlet needs to be cleared for proper flap gate operation. (O.Yakimov - DWR UCIP) FIELD_STRUCT_DESC: 24-inch corrugated metal drainage pipe through the levee, 4.5 feet below the crown. Flap gate and concrete U-shaped headwall on the waterside (WS) end. Concrete U-shaped headwall on the landside (LS) end. [Additional Reference(s): DWR Levee Log, 1992. USACE Sacramento O&M Manual 510, April 1963, (HLM 0.39) Drawing No. 50-4-3622]. FS Date: 5/28/2019 9:41:55 AM

Water-Side

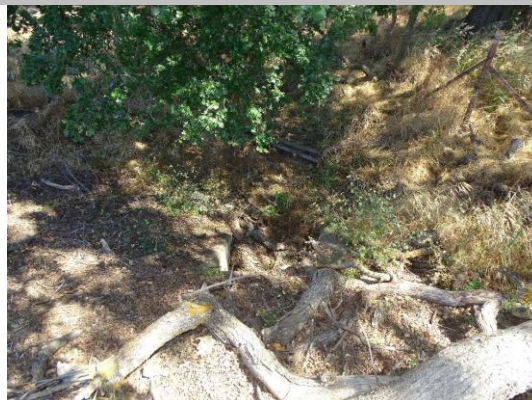
Photo 3 of 3 : UCIP_FA_2019_54115_79547.jpg

Land-Side

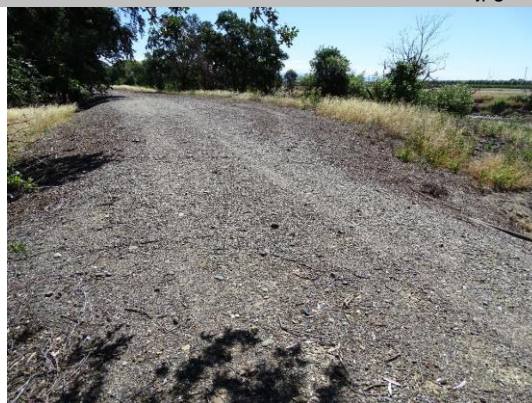
Photo 1 of 3 : UCIP_FA_2019_54116_79551.jpg

Comment Code					
Inspector Comment					
DS_ID:20777					
FS_ID:54116					
EP_NO: N/A					
Repair Type: Non-Urgent					
Crossing Status: Found					
UCIP Comments: 05/28/2019 Debris at the outlet needs to be cleared for proper flap gate operation. (O.Yakimov - DWR UCIP)					
FIELD_STRUCT_DESC: 24-inch corrugated metal drainage pipe through the levee, 5 feet below the crown. Flap gate and concrete U-shaped headwall on the waterside (WS) end. Concrete U-shaped headwall on the landside (LS) end. [Additional Reference(s): DWR Levee Log, 1992. USACE Sacramento O&M Manual 510, April 1963, (HLM 0.52) Drawing No. 50-4-3622].					
FS Date: 5/28/2019 9:54:39 AM

Top of Levee

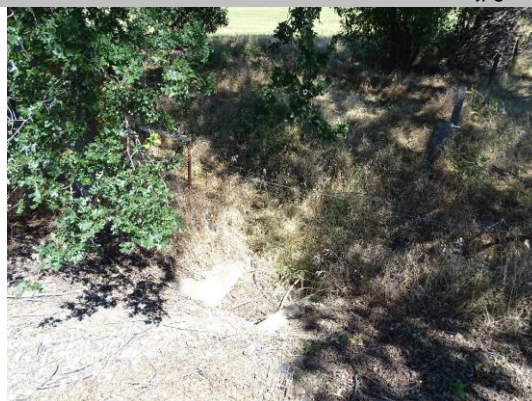
Photo 2 of 3 : UCIP_FA_2019_54116_79552.jpg

Comment Code						
Inspector Comment						
DS_ID:20777						
FS_ID:54116						
EP_NO: N/A						
Repair Type: Non-Urgent						
Crossing Status: Found						
UCIP Comments: 05/28/2019 Debris at the outlet needs to be cleared for proper flap gate operation. (O.Yakimov - DWR UCIP)						
FIELD_STRUCT_DESC: 24-inch corrugated metal drainage pipe through the levee, 5 feet below the crown. Flap gate and concrete U-shaped headwall on the waterside (WS) end. Concrete U-shaped headwall on the landside (LS) end. [Additional Reference(s): DWR Levee Log, 1992. USACE Sacramento O&M Manual 510, April 1963, (HLM 0.52) Drawing No. 50-4-3622].						
FS Date: 5/28/2019 9:54:39 AM

Land-Side

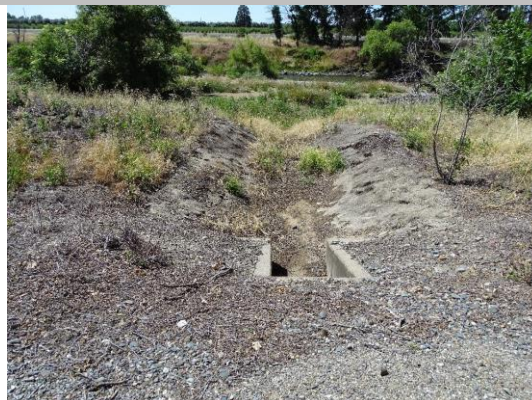
Photo 3 of 3 : UCIP_FA_2019_54116_79554.jpg

Water-Side

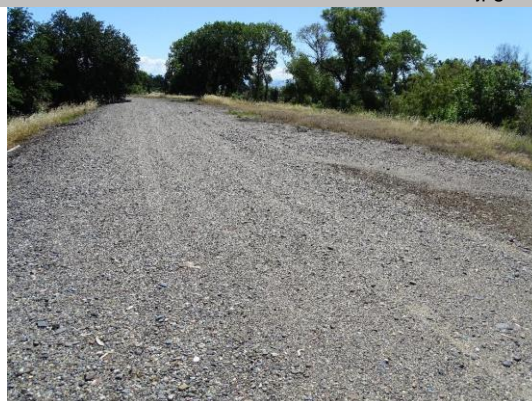
Photo 1 of 3 : UCIP_FA_2019_54117_79557.jpg

LM Start	0.64	Rating **	M	Issue No.	920
LM End	0.64	Issue Type +	Ma	Location *	
Category	Supplemental			GPS Latitude/Longitude	
				Start	End
Item	DRAFT DWR UCIP LMA Responsibility			40.051699 °	40.051699 °
				-122.177320 °	-122.177320 °
DWR ID	20778				
Comment Code					
Inspector Comment					
DS_ID:20778 FS_ID:54117 EP_NO: N/A Repair Type: Non-Urgent Crossing Status: Found UCIP Comments: 05/28/2019 No issues recorded during inspection (O.Yakimov - DWR UCIP) FIELD_STRUCT_DESC: 1 of 2: 36-inch corrugated metal drainage pipe through the levee, 8.6 feet below the crown. Flap gate and concrete U-shaped headwall on the waterside (WS) end. Concrete U-shaped headwall on the landside (LS) end. [Additional Reference(s): DWR Levee Log, 1992. USACE Sacramento O&M Manual 510, April 1963, (HLM 0.65) Drawing No. 50-4-3622]. FS Date: 5/28/2019 10:22:34 AM

View of levee crown at crossing

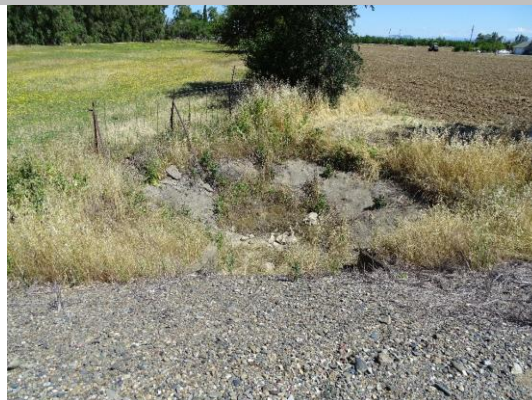
Photo 2 of 3 : UCIP_FA_2019_54117_79558.jpg

View of LS

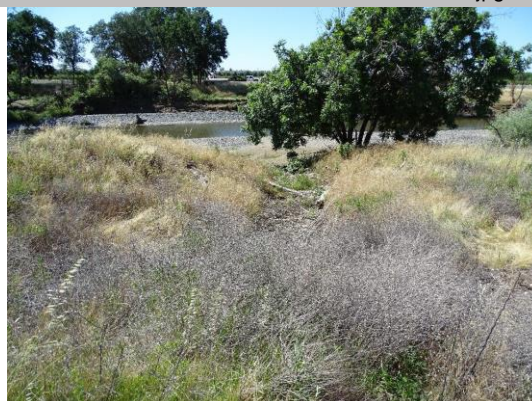
Photo 3 of 3 : UCIP_FA_2019_54117_79559.jpg

Comment Code						
Inspector Comment						
DS_ID:20778						
FS_ID:54117						
EP_NO: N/A						
Repair Type: Non-Urgent						
Crossing Status: Found						
UCIP Comments: 05/28/2019 No issues recorded during inspection (O.Yakimov - DWR UCIP)						
FIELD_STRUCT_DESC: 1 of 2: 36-inch corrugated metal drainage pipe through the levee, 8.6 feet below the crown. Flap gate and concrete U-shaped headwall on the waterside (WS) end. Concrete U-shaped headwall on the landside (LS) end. [Additional Reference(s): DWR Levee Log, 1992. USACE Sacramento O&M Manual 510, April 1963, (HLM 0.65) Drawing No. 50-4-3622].						
FS Date: 5/28/2019 10:22:34 AM

View of WS

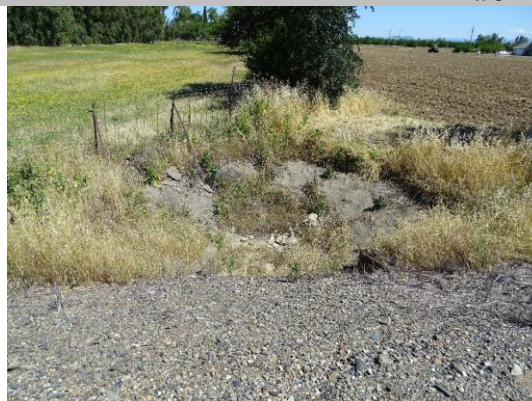
Photo 2 of 3 : UCIP_FA_2019_54118_79565.jpg

Comment Code					
Inspector Comment					
DS_ID:20880 FS_ID:54118 EP_NO: N/A Repair Type: Non-Urgent Crossing Status: Found UCIP Comments: 05/28/2019 No issues recorded during inspection (O.Yakimov - DWR UCIP)12/05/2016 Crossing has been downgraded from Urgent to Non-Urgent vegetation found on WS but does not appear to prevent proper function of flap gate. Recommend clearing dry vegetation on WS above concrete headwall.(O. Magana - DWR UCIP)10/03/2013 Flapgate operation hindered by soil and vegetation on WS toe. (W. Wylie - DWR UCIP) FIELD_STRUCT_DESC: 2 of 2: 36-inch corrugated metal drainage pipe through levee, 8.6 feet below crown. Flap gate and concrete "U" headwall located on the waterside (WS) end. Concrete "U" headwall located on the landside (LS) end. [Additional Reference(s): DWR Levee Log, 1992. USACE Sacramento O&M Manual, Unit 510, April 1963, As-built drawing No. 50-4-3622 (HLM 0.65)] FS Date: 5/28/2019 10:27:16 AM

View of LS

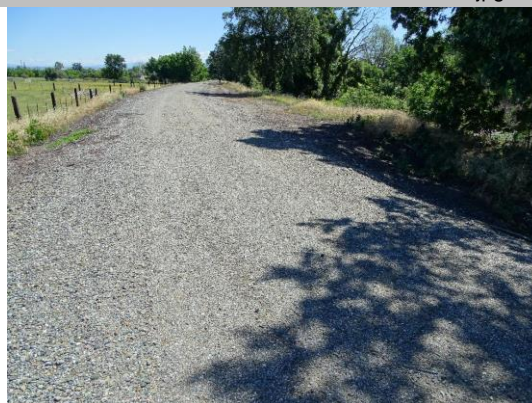
Photo 1 of 3 : UCIP_FA_2019_54119_79571.jpg

LM Start	0.75	Rating **	M	Issue No.	922
LM End	0.75	Issue Type +	Ma	Location *	
Category	Supplemental			GPS Latitude/Longitude	
				Start	End
Item	DRAFT DWR UCIP LMA Responsibility			40.052194 °	40.052194 °
				-122.175390 °	-122.175390 °
DWR ID	20779				
Comment Code					
Inspector Comment					
DS_ID:20779 FS_ID:54119 EP_NO: N/A Repair Type: Non-Urgent Crossing Status: Found UCIP Comments: 05/28/2019 Pipe is partially filled with silt and debris. (O.Yakimov - DWR UCIP) FIELD_STRUCT_DESC: 24-inch corrugated metal drainage pipe through the levee, 5.8 feet below the crown. Flap gate and concrete U-shaped headwall on the waterside (WS) end. Concrete U-shaped headwall on the landside (LS) end. [Additional Reference(s): DWR Levee Log, 1992. USACE Sacramento O&M Manual 510, April 1963, (HLM 0.76) Drawing No. 50-4-3622]. FS Date: 5/28/2019 10:30:54 AM

Top of Levee

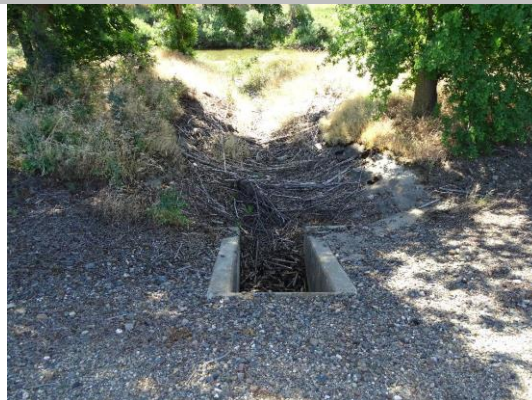
Photo 2 of 3 : UCIP_FA_2019_54119_79572.jpg

View of WS

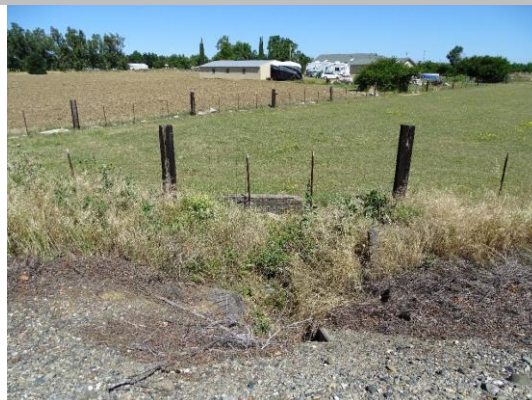
Photo 3 of 3 : UCIP_FA_2019_54119_79573.jpg

View of LS

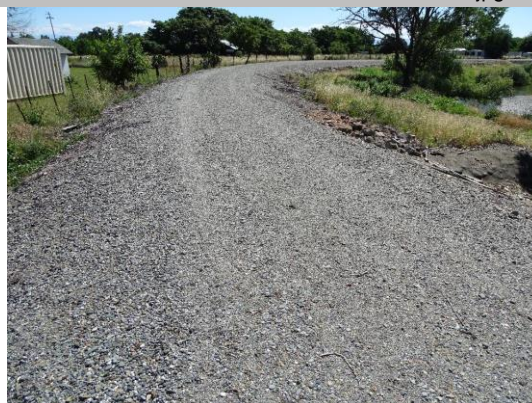
Photo 1 of 3 : UCIP_FA_2019_54120_79577.jpg

Comment Code						
Inspector Comment						
DS_ID:20780						
FS_ID:54120						
EP_NO: N/A						
Repair Type: Non-Urgent						
Crossing Status: Found						
UCIP Comments: 05/28/2019 Pipe is slightly filled with silt and debris.						
(O.Yakimov - DWR UCIP)						
FIELD_STRUCT_DESC: 24-inch corrugated metal drainage pipe						
through the levee, 4.5 feet below the crown. Flap gate and concrete U-						
shaped headwall on the waterside (WS) end. Concrete U-shaped						
headwall on the landside (LS) end. [Additional Reference(s): DWR						
Levee Log, 1992. USACE Sacramento O&M Manual 510, April 1963,						
(HLM 0.93) Drawing No. 50-4-3622].						
FS Date: 5/28/2019 11:11:41 AM

View of levee crown at the crossing

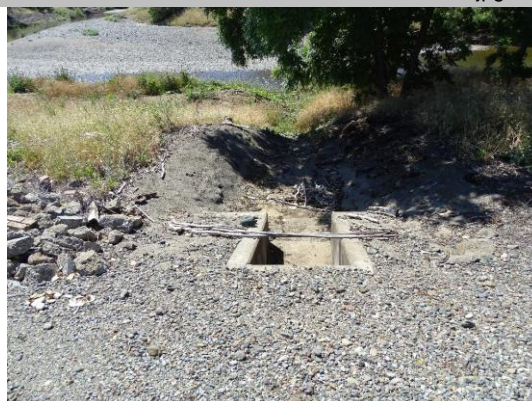
Photo 2 of 3 : UCIP_FA_2019_54120_79578.jpg

Concrete U-shaped headwall on WS toe

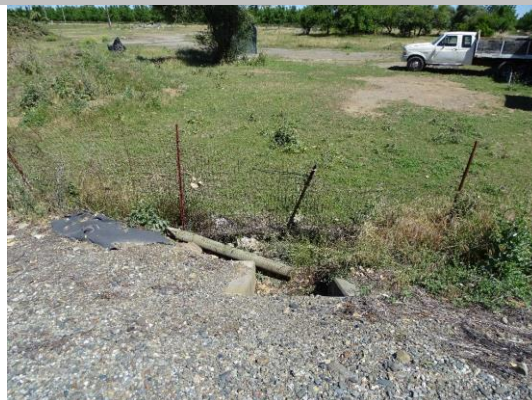
Photo 3 of 3 : UCIP_FA_2019_54120_79579.jpg

Concrete U-shaped headwall at LS toe

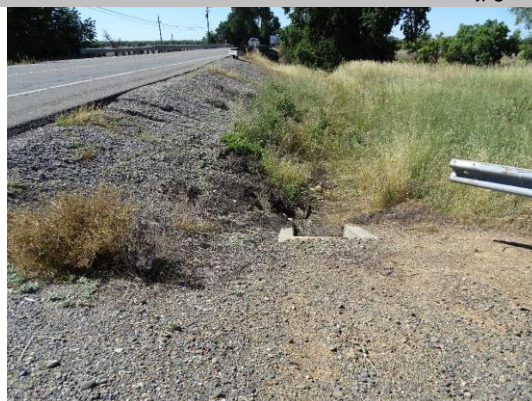
Photo 1 of 3 : UCIP_FA_2019_54121_79582.jpg

LM Start	1.07	Rating **	M	Issue No.	924
LM End	1.07	Issue Type +	Ma	Location *	
Category	Supplemental			GPS Latitude/Longitude	
				Start	End
Item	DRAFT DWR UCIP LMA Responsibility			40.052400 °	40.052400 °
				-122.170279 °	-122.170279 °
DWR ID	20790				
Comment Code					
Inspector Comment					
DS_ID:20790					
FS_ID:54121					
EP_NO: N/A					
Repair Type: Non-Urgent					
Crossing Status: Found					
UCIP Comments: 05/28/2019 No issues recorded during inspection (O.Yakimov - DWR UCIP)					
FIELD_STRUCT_DESC: 24-inch corrugated metal drainage pipe through the levee, 5 feet below the crown. Flap gate and concrete U-shaped headwall on the waterside (WS) end. Concrete U-shaped headwall on the landside (LS) end. [Additional Reference(s): DWR Levee Log, 1992. USACE Sacramento O&M Manual 510, April 1963, (HLM 1.10) Drawing No. 50-4-3622].					
FS Date: 5/28/2019 11:19:17 AM

View of WS with concrete U-shaped headwall and levee toe

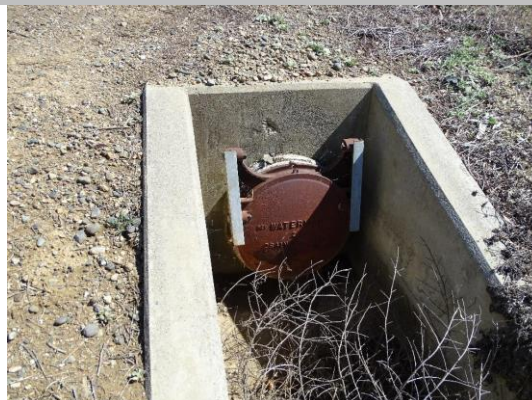
Photo 2 of 3 : UCIP_FA_2019_54121_79583.jpg

Concrete U-shaped headwall and flapgate on WS toe

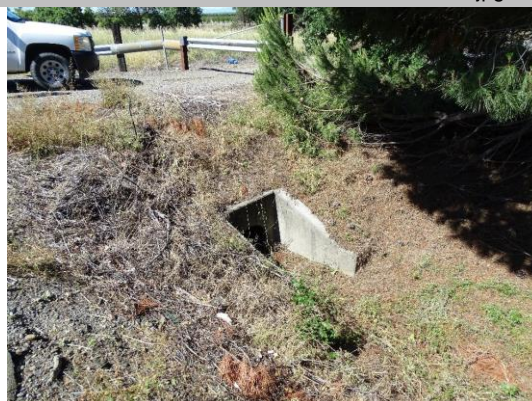
Photo 3 of 3 : UCIP_FA_2019_54121_79584.jpg

Comment Code						
Inspector Comment						
DS_ID:20790						
FS_ID:54121						
EP_NO: N/A						
Repair Type: Non-Urgent						
Crossing Status: Found						
UCIP Comments: 05/28/2019 No issues recorded during inspection (O.Yakimov - DWR UCIP)						
FIELD_STRUCT_DESC: 24-inch corrugated metal drainage pipe through the levee, 5 feet below the crown. Flap gate and concrete U-shaped headwall on the waterside (WS) end. Concrete U-shaped headwall on the landside (LS) end. [Additional Reference(s): DWR Levee Log, 1992. USACE Sacramento O&M Manual 510, April 1963, (HLM 1.10) Drawing No. 50-4-3622].						
FS Date: 5/28/2019 11:19:17 AM

LS levee slope

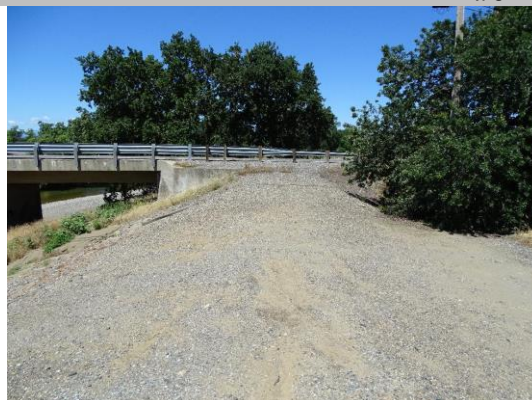
Photo 1 of 3 : UCIP_FA_2019_54123_79589.jpg

LM Start	1.11	Rating **	M	Issue No.	925	
LM End	1.11	Issue Type +	Ma	Location *		
Category	Supplemental			GPS Latitude/Longitude		
				Start		End
Item	DRAFT DWR UCIP LMA Responsibility			40.051958 °		40.051958 °
				-122.170031 °		-122.170031 °
DWR ID	20773					
Comment Code						
Inspector Comment						
DS_ID:20773 FS_ID:54123 EP_NO: N/A Repair Type: Non-Urgent Crossing Status: Found UCIP Comments: 05/28/2019 No issues recorded during inspection (O.Yakimov - DWR UCIP) FIELD_STRUCT_DESC: 24-inch corrugated metal drainage pipe through the levee, 5.1 feet below the crown. Flap gate and concrete U-shaped headwall on the waterside (WS) end. Concrete U-shaped headwall on the landside (LS) end. [Additional Reference(s): DWR Levee Log, 1992. USACE Sacramento O&M Manual 510, April 1963, (HLM 1.12) Drawing No. 50-4-3622]. FS Date: 5/28/2019 11:34:16 AM

View of levee crown at the crossing

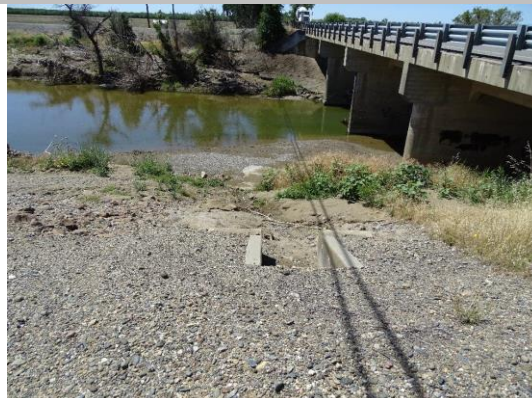
Photo 2 of 3 : UCIP_FA_2019_54123_79590.jpg

Comment Code						
Inspector Comment						
DS_ID:20773						
FS_ID:54123						
EP_NO: N/A						
Repair Type: Non-Urgent						
Crossing Status: Found						
UCIP Comments: 05/28/2019 No issues recorded during inspection (O.Yakimov - DWR UCIP)						
FIELD_STRUCT_DESC: 24-inch corrugated metal drainage pipe through the levee, 5.1 feet below the crown. Flap gate and concrete U-shaped headwall on the waterside (WS) end. Concrete U-shaped headwall on the landside (LS) end. [Additional Reference(s): DWR Levee Log, 1992. USACE Sacramento O&M Manual 510, April 1963, (HLM 1.12) Drawing No. 50-4-3622].						
FS Date: 5/28/2019 11:34:16 AM

WS slope with concrete U-shaped headwall at the toe

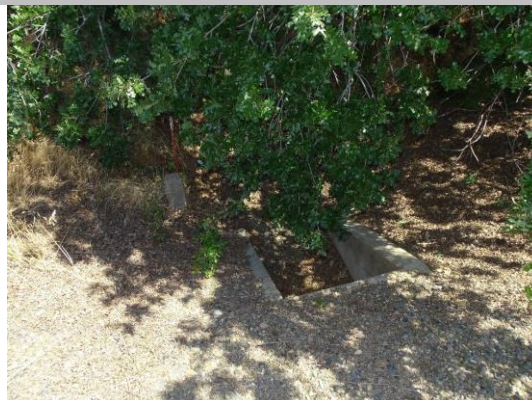
Photo 3 of 3 : UCIP_FA_2019_54123_79591.jpg

LS slope with concrete U-shaped headwall at the toe

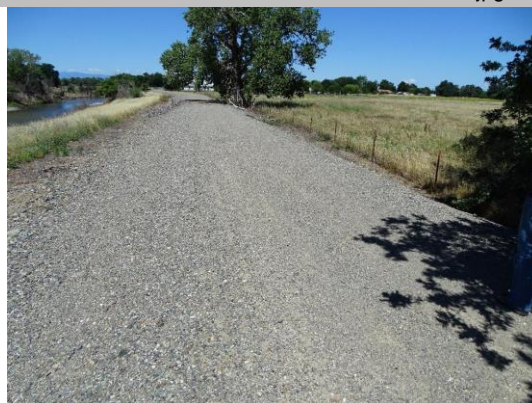
Photo 1 of 3 : UCIP_FA_2019_54124_79596.jpg

LM Start	1.30	Rating **	M	Issue No.	926
LM End	1.30	Issue Type +	Ma	Location *	
Category	Supplemental			GPS Latitude/Longitude	
				Start	End
Item	DRAFT DWR UCIP LMA Responsibility			40.051563 °	40.051563 °
				-122.166630 °	-122.166630 °
DWR ID	20782				
Comment Code					
Inspector Comment					
DS_ID:20782					
FS_ID:54124					
EP_NO: N/A					
Repair Type: Non-Urgent					
Crossing Status: Found					
UCIP Comments: 05/28/2019 No issues recorded during inspection (O.Yakimov - DWR UCIP)					
FIELD_STRUCT_DESC: 24-inch corrugated metal drainage pipe through the levee, 4.5 feet below the crown. Flap gate and concrete U-shaped headwall on the waterside (WS) end. Concrete U-shaped headwall on the landside (LS) end. [Additional Reference(s): DWR Levee Log, 1992. USACE Sacramento O&M Manual 510, April 1963, (HLM 1.30) Drawing No. 50-4-3622].					
FS Date: 5/28/2019 12:41:38 PM

View of levee crown at the crossing

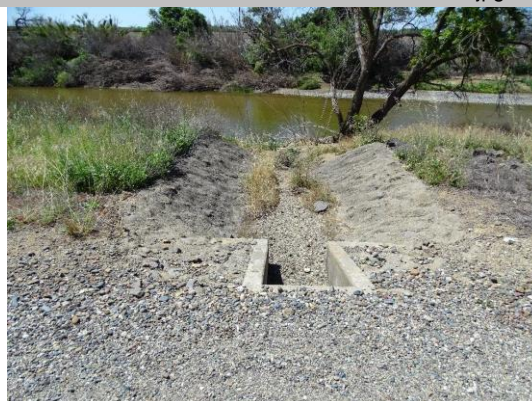
Photo 2 of 3 : UCIP_FA_2019_54124_79597.jpg

Water-Side

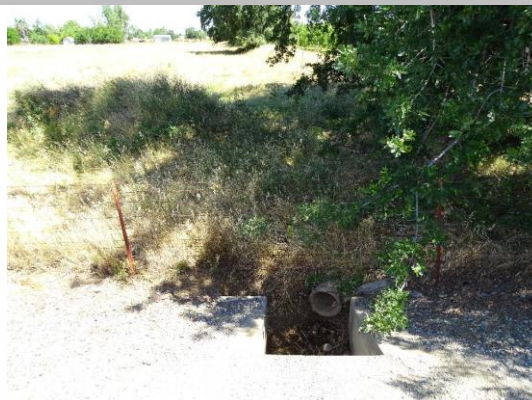
Photo 3 of 3 : UCIP_FA_2019_54124_79598.jpg

Land-Side

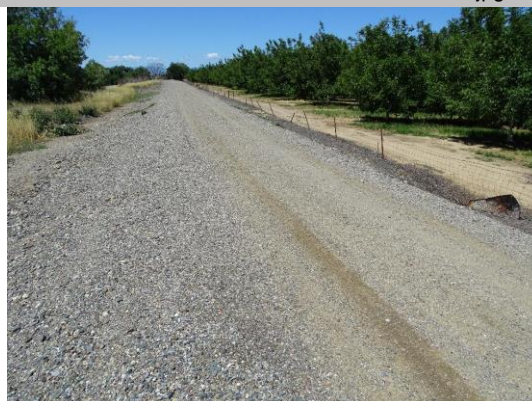
Photo 1 of 3 : UCIP_FA_2019_54125_79602.jpg

LM Start	1.56	Rating **	M	Issue No.	927
LM End	1.56	Issue Type +	Ma	Location *	
Category	Supplemental			GPS Latitude/Longitude	
				Start	End
Item	DRAFT DWR UCIP LMA Responsibility			40.052495 °	40.052495 °
				-122.161921 °	-122.161921 °
DWR ID	20783				
Comment Code					
Inspector Comment					
DS_ID:20783 FS_ID:54125 EP_NO: N/A Repair Type: Non-Urgent Crossing Status: Found UCIP Comments: 05/28/2019 Pipe is partially filled with silt and debris. (O.Yakimov - DWR UCIP) FIELD_STRUCT_DESC: 24-inch corrugated metal drainage pipe through the levee, 5.8 feet below the crown. Flap gate and concrete U-shaped headwall on the waterside (WS) end. Concrete U-shaped headwall on the landside (LS) end. [Additional Reference(s): DWR Levee Log, 1992. USACE Sacramento O&M Manual 510, April 1963, (HLM 1.57) Drawing No. 50-4-3622]. FS Date: 5/28/2019 12:53:39 PM

View of levee crown at the crossing

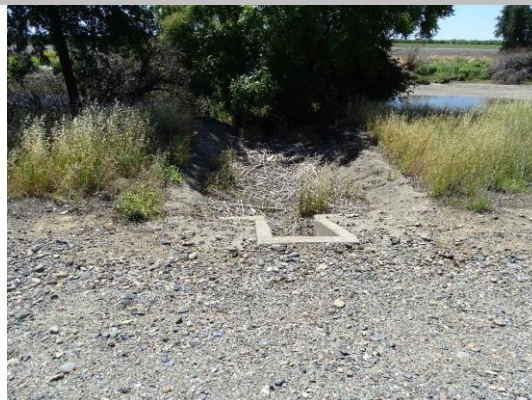
Photo 2 of 3 : UCIP_FA_2019_54125_79603.jpg

Water-Side

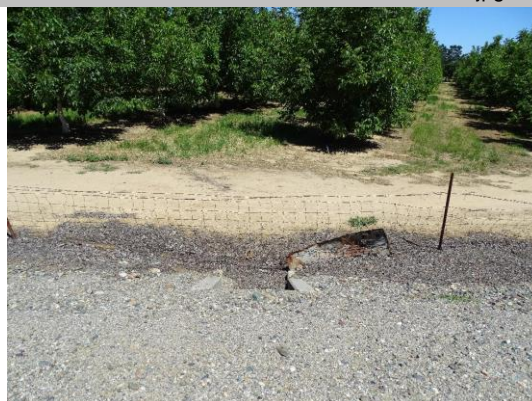
Photo 3 of 3 : UCIP_FA_2019_54125_79604.jpg

Land-Side

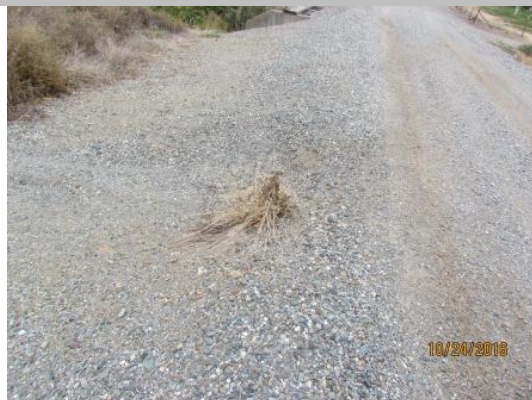
Photo 1 of 2 : FA_2019_NA0019_81_3_20190822_00003.jpg

LM Start	1.59	Rating **	A/W	Issue No.	3
LM End	1.59	Issue Type +	Ma	Location *	WS
Category	Earthen Levee			GPS Latitude/Longitude	
				Start	End
Item	Slope Stability			40.052607 °	40.052705 °
				-122.161418 °	-122.161442 °
DWR ID	DWR_NA0019_04_f_2018_3				
Comment Code					
S3 : Repair the levee slope damaged by vehicle traffic and prevent access where possible.					
Inspector Comment					
Tehama Co. repaired the slope that was damaged by vehicle traffic, but the damage has returned. On 4/26/16, vehicle erosion area was repaired again, but should be monitored.

View of a dip along the levee slope.

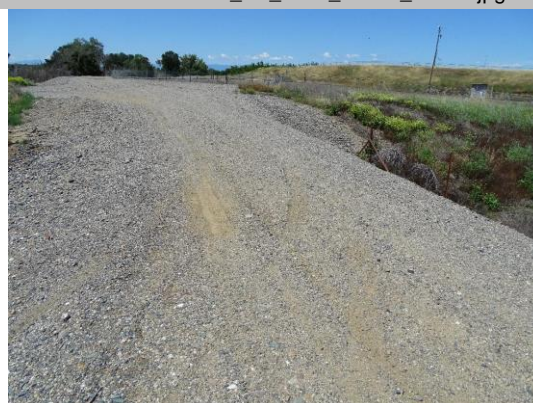
Photo 1 of 3 : UCIP_FA_2019_54130_79635.jpg

Comment Code					
Inspector Comment					
DS_ID:20786					
FS_ID:54130					
EP_NO: N/A					
Repair Type: Non-Urgent					
Crossing Status: Found					
UCIP Comments: 05/28/2019 Brush at pipe outlet, but doesn't seem to affect flap gate operation. (O.Yakimov - DWR UCIP)					
FIELD_STRUCT_DESC: 1 of 3: 36-inch corrugated metal drainage pipe through the levee, 7.3 feet below the crown. Flap gate and concrete U-shaped headwall on the waterside (WS) end. Concrete U-shaped headwall on the landside (LS) end. [Additional Reference(s): DWR Levee Log, 1992. USACE Sacramento O&M Manual 510, April 1963, (HLM 1.70) Drawing No. 50-4-3622].					
FS Date: 5/28/2019 2:18:51 PM

View of levee crown at the crossing

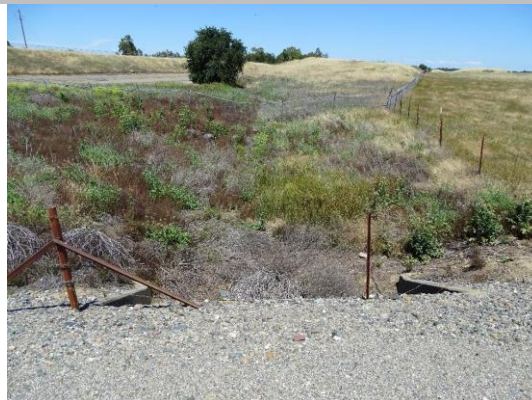
Photo 2 of 3 : UCIP_FA_2019_54130_79636.jpg

Comment Code						
Inspector Comment						
DS_ID:20786 FS_ID:54130 EP_NO: N/A Repair Type: Non-Urgent Crossing Status: Found UCIP Comments: 05/28/2019 Brush at pipe outlet, but doesn't seem to affect flap gate operation. (O.Yakimov - DWR UCIP) FIELD_STRUCT_DESC: 1 of 3: 36-inch corrugated metal drainage pipe through the levee, 7.3 feet below the crown. Flap gate and concrete U-shaped headwall on the waterside (WS) end. Concrete U-shaped headwall on the landside (LS) end. [Additional Reference(s): DWR Levee Log, 1992. USACE Sacramento O&M Manual 510, April 1963, (HLM 1.70) Drawing No. 50-4-3622]. FS Date: 5/28/2019 2:18:51 PM

View of LS

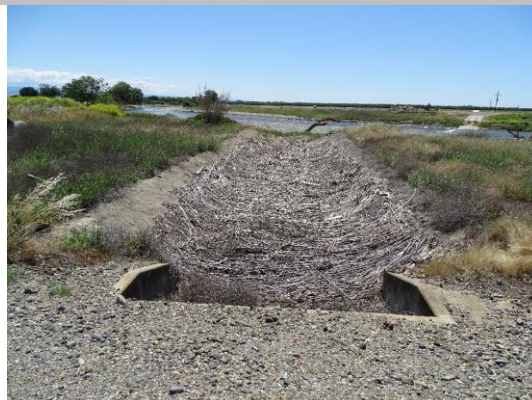
Photo 3 of 3 : UCIP_FA_2019_54130_79637.jpg

View of WS

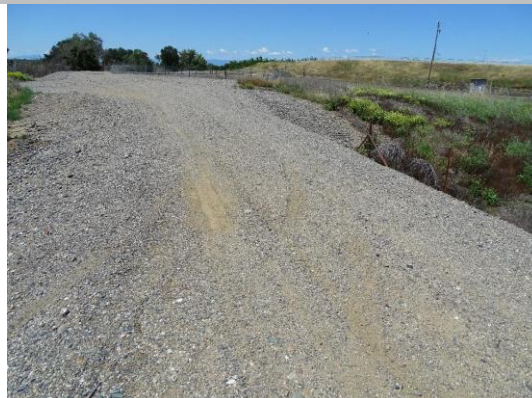
Photo 1 of 3 : UCIP_FA_2019_54131_79641.jpg

Comment Code					
Inspector Comment					
DS_ID:20883					
FS_ID:54131					
EP_NO: N/A					
Repair Type: Non-Urgent					
Crossing Status: Found					
UCIP Comments: 05/28/2019 Brush at pipe outlet, but doesn't seem to affect flap gate operation. (O.Yakimov - DWR UCIP)					
FIELD_STRUCT_DESC: 2 of 3: 36-inch corrugated metal drainage pipe through the levee, 7.3 feet below the crown. Flap gate and concrete U-shaped headwall on the waterside (WS) end. Concrete U-shaped headwall on the landside (LS) end. [Additional Reference(s): DWR Levee Log, 1992. USACE Sacramento O&M Manual 510, April 1963, (HLM 1.70) Drawing No. 50-4-3622].					
FS Date: 5/28/2019 2:24:53 PM

View of levee crown at the crossing

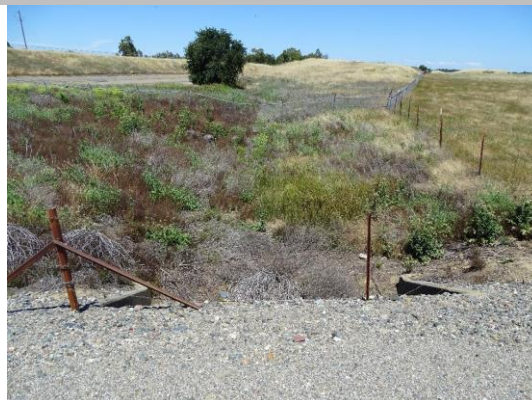
Photo 2 of 3 : UCIP_FA_2019_54131_79642.jpg

View of LS

Comment Code						
Inspector Comment						
DS_ID:20883						
FS_ID:54131						
EP_NO: N/A						
Repair Type: Non-Urgent						
Crossing Status: Found						
UCIP Comments: 05/28/2019 Brush at pipe outlet, but doesn't seem to affect flap gate operation. (O.Yakimov - DWR UCIP)						
FIELD_STRUCT_DESC: 2 of 3: 36-inch corrugated metal drainage pipe through the levee, 7.3 feet below the crown. Flap gate and concrete U-shaped headwall on the waterside (WS) end. Concrete U-shaped headwall on the landside (LS) end. [Additional Reference(s): DWR Levee Log, 1992. USACE Sacramento O&M Manual 510, April 1963, (HLM 1.70) Drawing No. 50-4-3622].						
FS Date: 5/28/2019 2:24:53 PM

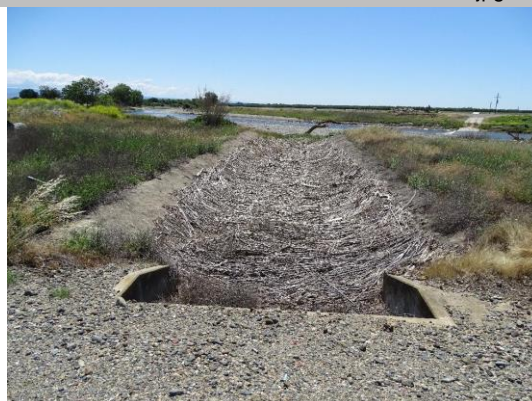
Photo 3 of 3 : UCIP_FA_2019_54131_79643.jpg

View of WS

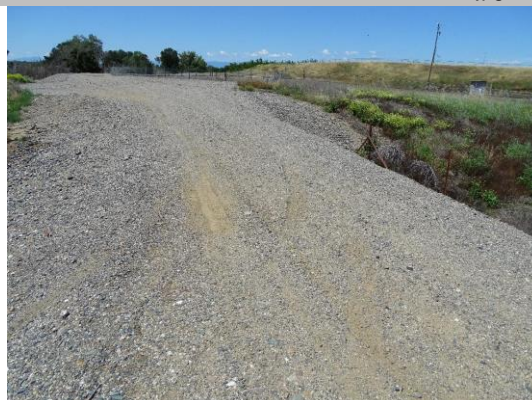
Photo 1 of 3 : UCIP_FA_2019_54132_79647.jpg

Comment Code					
Inspector Comment					
DS_ID:20884					
FS_ID:54132					
EP_NO: N/A					
Repair Type: Non-Urgent					
Crossing Status: Found					
UCIP Comments: 05/28/2019 Brush at pipe outlet, but doesn't seem to affect flap gate operation. (O.Yakimov - DWR UCIP)					
FIELD_STRUCT_DESC: 3 of 3: 36-inch corrugated metal drainage pipe through the levee, 7.3 feet below the crown. Flap gate and concrete U-shaped headwall on the waterside (WS) end. Concrete U-shaped headwall on the landside (LS) end. [Additional Reference(s): DWR Levee Log, 1992. USACE Sacramento O&M Manual 510, April 1963, (HLM 1.70) Drawing No. 50-4-3622].					
FS Date: 5/28/2019 2:26:20 PM

View of levee crown at the crossing

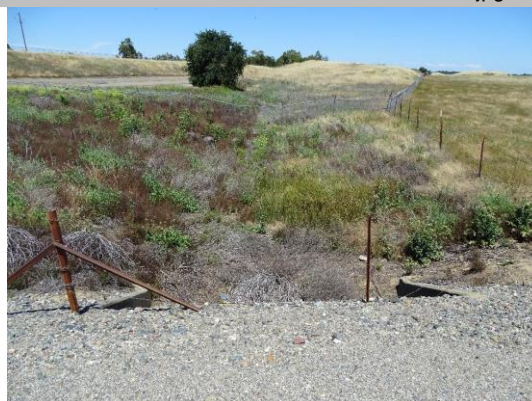
Photo 2 of 3 : UCIP_FA_2019_54132_79648.jpg

Comment Code						
Inspector Comment						
DS_ID:20884 FS_ID:54132 EP_NO: N/A Repair Type: Non-Urgent Crossing Status: Found UCIP Comments: 05/28/2019 Brush at pipe outlet, but doesn't seem to affect flap gate operation. (O.Yakimov - DWR UCIP) FIELD_STRUCT_DESC: 3 of 3: 36-inch corrugated metal drainage pipe through the levee, 7.3 feet below the crown. Flap gate and concrete U-shaped headwall on the waterside (WS) end. Concrete U-shaped headwall on the landside (LS) end. [Additional Reference(s): DWR Levee Log, 1992. USACE Sacramento O&M Manual 510, April 1963, (HLM 1.70) Drawing No. 50-4-3622]. FS Date: 5/28/2019 2:26:20 PM

View of LS

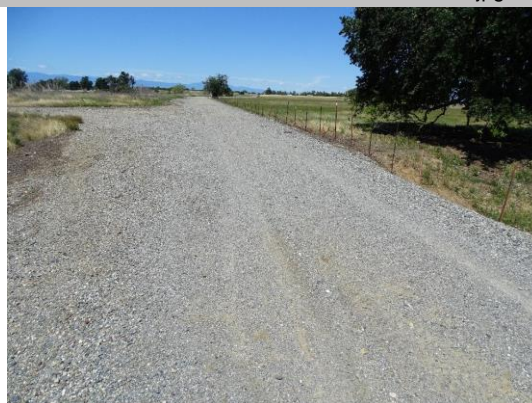
Photo 1 of 3 : UCIP_FA_2019_54133_79654.jpg

LM Start	1.99	Rating **	M	Issue No.	935
LM End	1.99	Issue Type +	Ma	Location *	
Category	Supplemental			GPS Latitude/Longitude	
				Start	End
Item	DRAFT DWR UCIP LMA Responsibility			40.052731 °	40.052731 °
				-122.154695 °	-122.154695 °
DWR ID	20787				
Comment Code					
Inspector Comment					
DS_ID:20787					
FS_ID:54133					
EP_NO: N/A					
Repair Type: Non-Urgent					
Crossing Status: Found					
UCIP Comments: 05/28/2019 No issues recorded during inspection (O.Yakimov - DWR UCIP)					
FIELD_STRUCT_DESC: 1 of 2: 36-inch corrugated metal drainage pipe through the levee, 7.6 feet below the crown. Flap gate and concrete U-shaped headwall on the waterside (WS) end. Concrete U-shaped headwall on the landside (LS) end. [Additional Reference(s): DWR Levee Log, 1992. USACE Sacramento O&M Manual 510, April 1963, (HLM 2.01) Drawing No. 50-4-3622].					
FS Date: 5/28/2019 2:33:09 PM

View of levee crown at the crossing

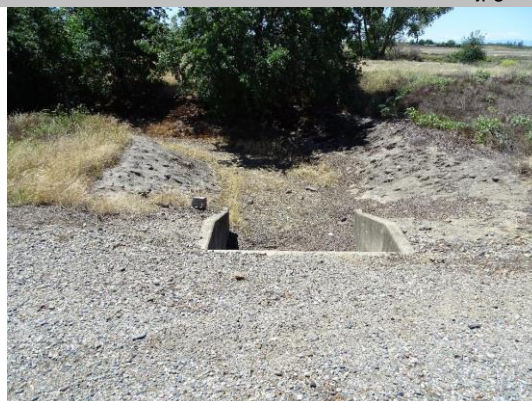
Photo 2 of 3 : UCIP_FA_2019_54133_79655.jpg

Comment Code						
Inspector Comment						
DS_ID:20787						
FS_ID:54133						
EP_NO: N/A						
Repair Type: Non-Urgent						
Crossing Status: Found						
UCIP Comments: 05/28/2019 No issues recorded during inspection (O.Yakimov - DWR UCIP)						
FIELD_STRUCT_DESC: 1 of 2: 36-inch corrugated metal drainage pipe through the levee, 7.6 feet below the crown. Flap gate and concrete U-shaped headwall on the waterside (WS) end. Concrete U-shaped headwall on the landside (LS) end. [Additional Reference(s): DWR Levee Log, 1992. USACE Sacramento O&M Manual 510, April 1963, (HLM 2.01) Drawing No. 50-4-3622].						
FS Date: 5/28/2019 2:33:09 PM

View of WS

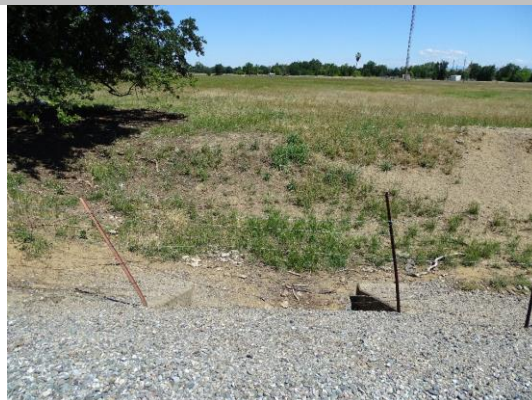
Photo 3 of 3 : UCIP_FA_2019_54133_79656.jpg

View of LS

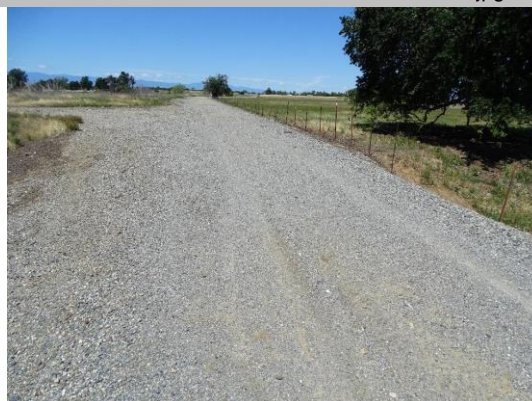
Photo 1 of 3 : UCIP_FA_2019_54134_79660.jpg

Comment Code						
Inspector Comment						
DS_ID:20885						
FS_ID:54134						
EP_NO: N/A						
Repair Type: Non-Urgent						
Crossing Status: Found						
UCIP Comments: 05/28/2019 No issues recorded during inspection (O.Yakimov - DWR UCIP)						
FIELD_STRUCT_DESC: 2 of 2: 36-inch corrugated metal drainage pipe through the levee, 7.6 feet below the crown. Flap gate and concrete U-shaped headwall on the waterside (WS) end. Concrete U-shaped headwall on the landside (LS) end. [Additional Reference(s): DWR Levee Log, 1992. USACE Sacramento O&M Manual 510, April 1963, (HLM 2.01) Drawing No. 50-4-3622].						
FS Date: 5/28/2019 2:38:32 PM

View of levee crown at the crossing

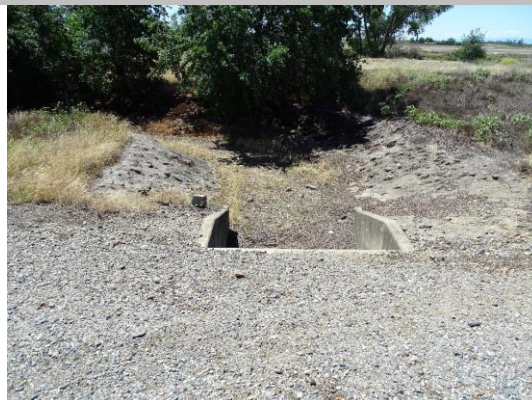
Photo 2 of 3 : UCIP_FA_2019_54134_79661.jpg

View of WS

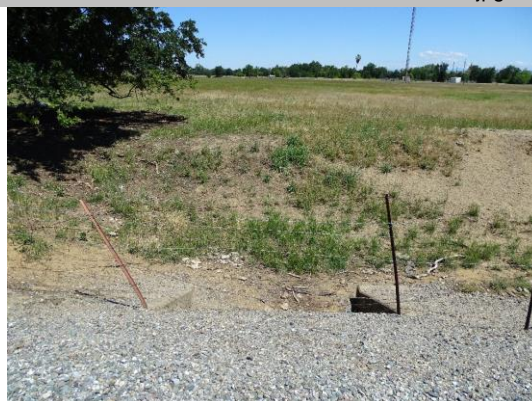
Photo 3 of 3 : UCIP_FA_2019_54134_79662.jpg

LM Start	1.99	Rating **	M	Issue No.	936 (cont)	
LM End	1.99	Issue Type +	Ma	Location *		
Category	Supplemental			GPS Latitude/Longitude		
				Start		End
Item	DRAFT DWR UCIP LMA Responsibility			40.052729 °		40.052729 °
				-122.154673 °		-122.154673 °
DWR ID	20885					
Comment Code						
Inspector Comment						
DS_ID:20885 FS_ID:54134 EP_NO: N/A Repair Type: Non-Urgent Crossing Status: Found UCIP Comments: 05/28/2019 No issues recorded during inspection (O.Yakimov - DWR UCIP) FIELD_STRUCT_DESC: 2 of 2: 36-inch corrugated metal drainage pipe through the levee, 7.6 feet below the crown. Flap gate and concrete U-shaped headwall on the waterside (WS) end. Concrete U-shaped headwall on the landside (LS) end. [Additional Reference(s): DWR Levee Log, 1992. USACE Sacramento O&M Manual 510, April 1963, (HLM 2.01) Drawing No. 50-4-3622]. FS Date: 5/28/2019 2:38:32 PM

View of LS

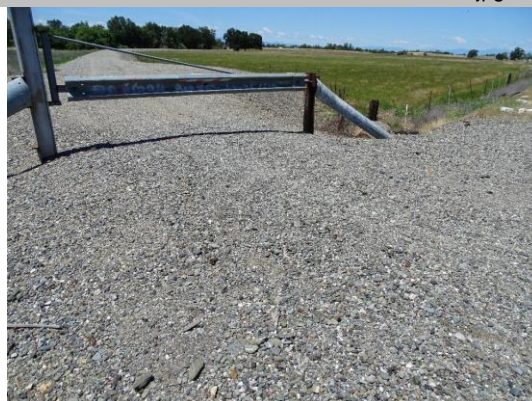
Photo 1 of 3 : UCIP_FA_2019_54135_79666.jpg

Comment Code						
Inspector Comment						
DS_ID:20788						
FS_ID:54135						
EP_NO: N/A						
Repair Type: Non-Urgent						
Crossing Status: Found						
UCIP Comments: 05/28/2019 No issues recorded during inspection (O.Yakimov - DWR UCIP)						
FIELD_STRUCT_DESC: 24-inch corrugated metal drainage pipe through the levee, 5.9 feet below the crown. Flap gate and concrete U-shaped headwall on the waterside (WS) end. Concrete U-shaped headwall on the landside (LS) end. [Additional Reference(s): DWR Levee Log, 1992. USACE Sacramento O&M Manual 510, April 1963, (HLM 2.24) Drawing No. 50-4-3622].						
FS Date: 5/28/2019 2:44:10 PM

View of levee crown at the crossing

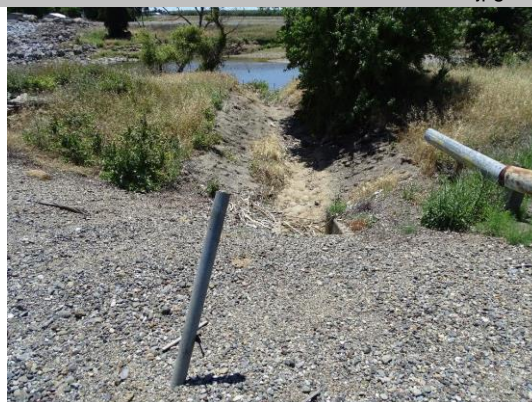
Photo 2 of 3 : UCIP_FA_2019_54135_79667.jpg

View of WS

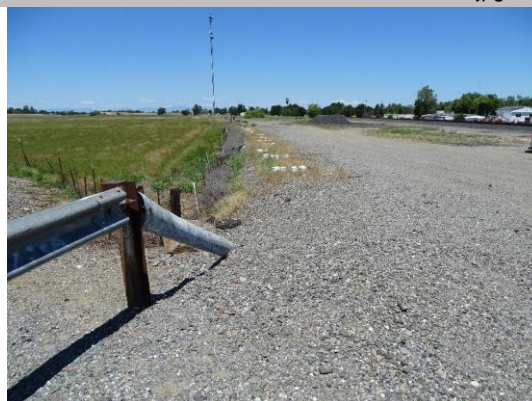
Photo 3 of 3 : UCIP_FA_2019_54135_79669.jpg

Comment Code						
Inspector Comment						
DS_ID:20788						
FS_ID:54135						
EP_NO: N/A						
Repair Type: Non-Urgent						
Crossing Status: Found						
UCIP Comments: 05/28/2019 No issues recorded during inspection (O.Yakimov - DWR UCIP)						
FIELD_STRUCT_DESC: 24-inch corrugated metal drainage pipe through the levee, 5.9 feet below the crown. Flap gate and concrete U-shaped headwall on the waterside (WS) end. Concrete U-shaped headwall on the landside (LS) end. [Additional Reference(s): DWR Levee Log, 1992. USACE Sacramento O&M Manual 510, April 1963, (HLM 2.24) Drawing No. 50-4-3622].						
FS Date: 5/28/2019 2:44:10 PM

View of LS

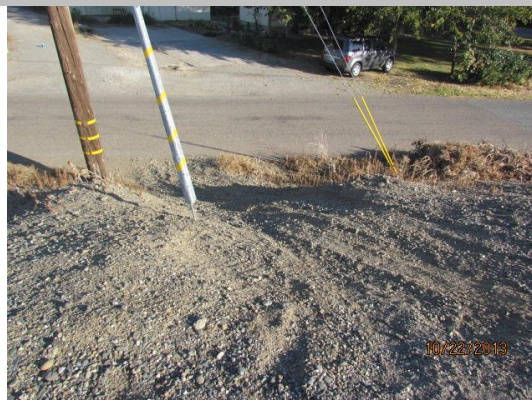
Photo 1 of 1 : FA_2019_NA0019_81_12_20190822_00007.jpg

LM Start	2.32	Rating **	M	Issue No.	12
LM End	2.32	Issue Type +	Ma	Location *	LS
Category	Earthen Levee			GPS Latitude/Longitude	
				Start	End
Item	Slope Stability			40.052443 °	40.052443 °
				-122.148863 °	-122.148863 °
DWR ID	DWR_NA0019_04_f_2013_12				
Comment Code					
S3 : Repair the levee slope damaged by vehicle traffic and prevent access where possible.					
Inspector Comment

View of the slope instability caused by vehicles along the landside slope.

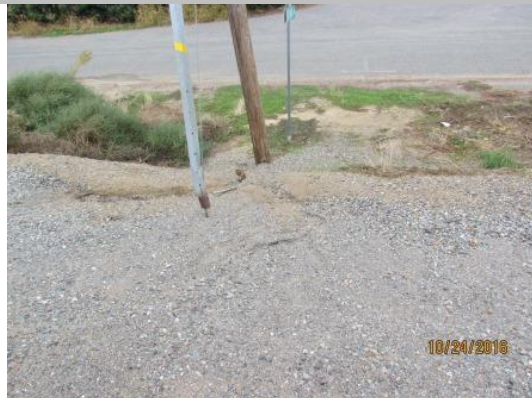
Photo 1 of 1 : FA_2019_NA0019_81_32_20190822_00018.jpg

LM Start	2.58	Rating **	M	Issue No.	32
LM End	2.58	Issue Type +	Ma	Location *	LS
Category	Earthen Levee			GPS Latitude/Longitude	
				Start	End
Item	Slope Stability			40.053767 °	40.053767 °
				-122.144719 °	-122.144719 °
DWR ID	DWR_NA0019_04_f_2016_32				
Comment Code					
S2 : Repair the levee slope damaged by foot traffic and prevent access where possible.					
Inspector Comment

View of the slope instability caused by vehicles along the landside slope.
